Seismic vulnerability assessment of buildings of Patna by rapid visual screening

Siddharth^{1*} and Ajay Kumar Sinha²

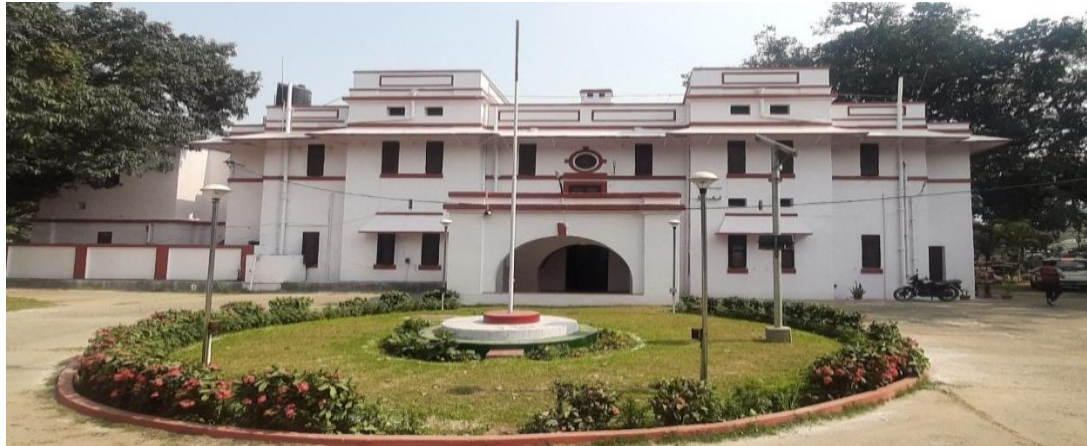
Figure 6 Front view of main buildings of 1, Desh Ratna Marg (Residence of Late CM Karpoori Thakur)

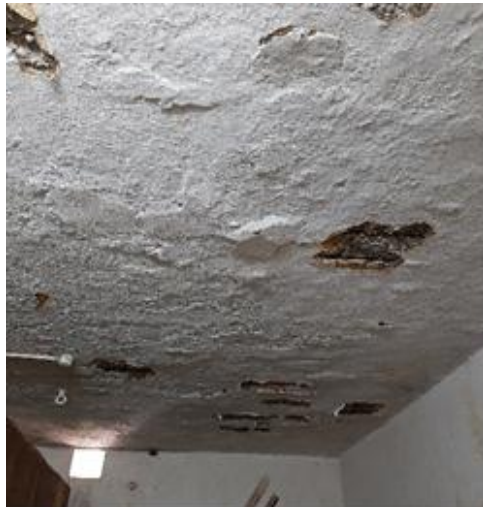
Figure 6 is the front view of the building. *Figure 7* shows spalling in ceiling inside the buildings. These are most common problems in URM buildings. *Figure 8* shows the dampness on the walls of the buildings. This may have deteriorating effects on the strength of the buildings. *Figure 9* represents walls with plaster damage. *Figure 10* shows corrosion of reinforcement of roofs.

Figure 7 Spalling in ceiling

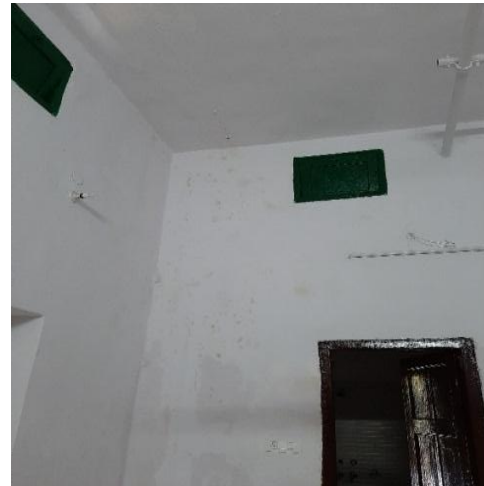
Figure 8 Dampness on walls

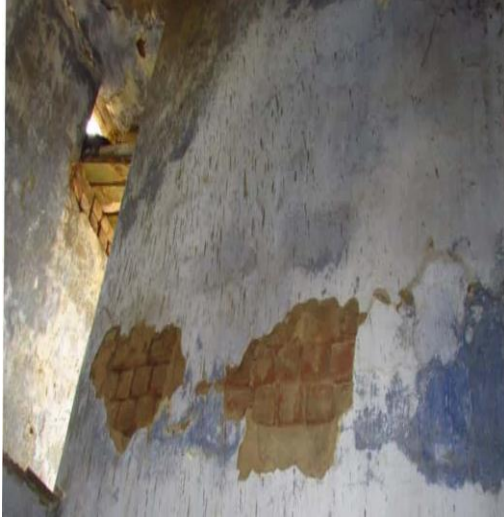
Figure 9 Deterioration of walls

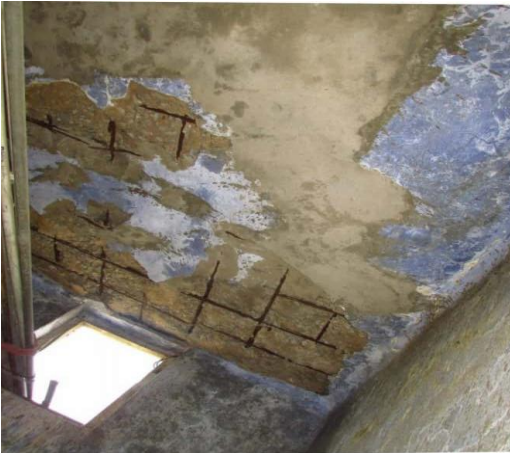
Figure 10 Corrosion reinforcement of the ceiling

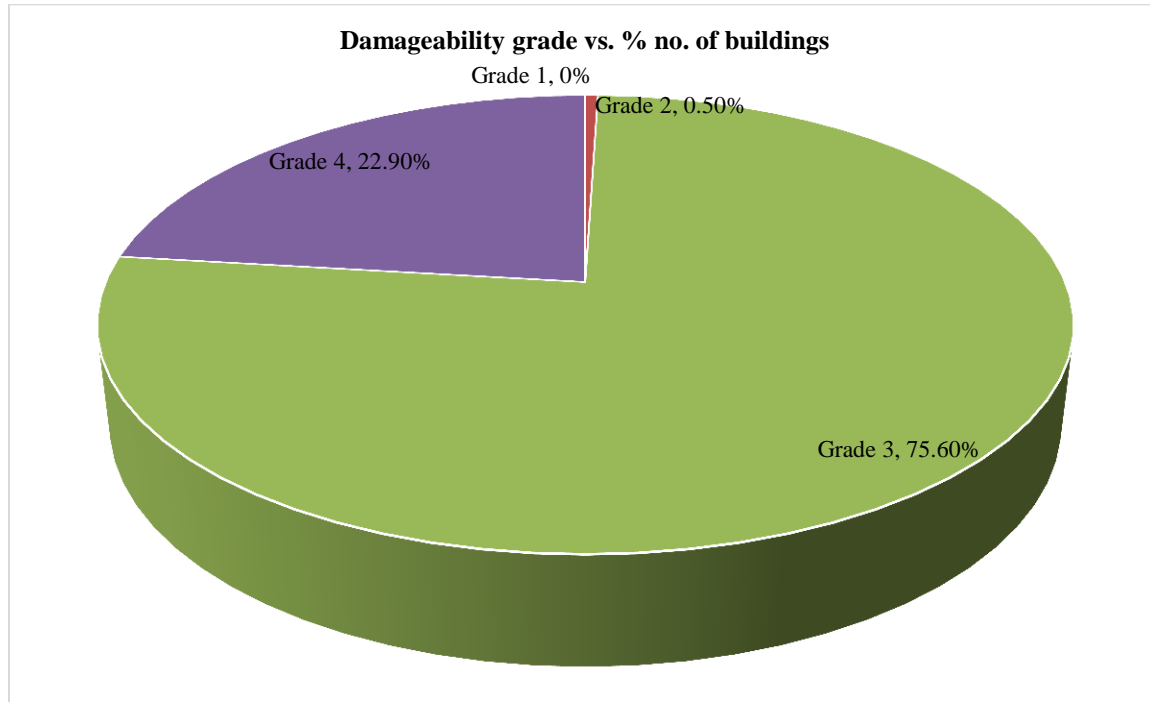
The *Figure 11* shows the pie chart for comparison between damageability grade and percentage no of buildings. The percentage of grade 3 buildings were more than grade 4 damage buildings. Also, there were no grade 1 damage buildings. The *Table 3* shows the classification of surveyed buildings based upon the height of the buildings. The height of the building also affects the vulnerability of building. The *Figure 12* shows the pie chart for comparison between storey height and percentage no of buildings. The percentage of surveyed buildings having height >1 was more than single story building. Also, there were few buildings of single storey.

Figure 11 Pie chart of classification based upon damageability grade

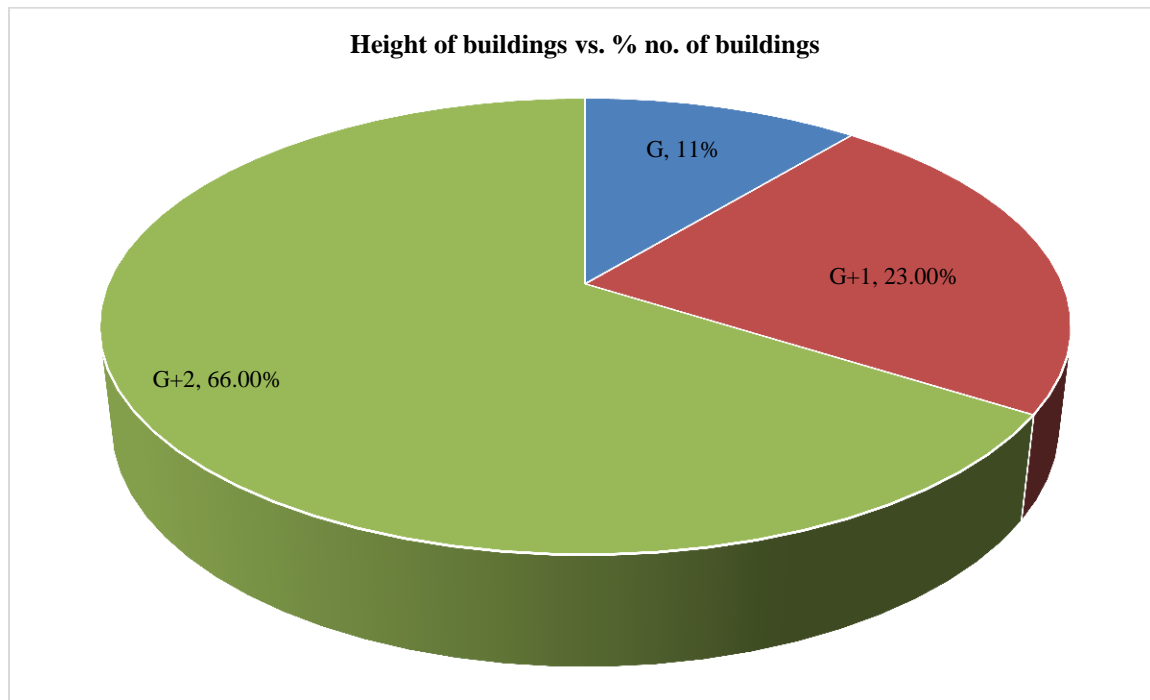
The *Figure 12* shows the pie chart for comparison between storey height and percentage no of buildings. The percentage of surveyed buildings having height >1 was more than single story building. Also, there were few buildings of single storey. The *Table 4* shows the classification of surveyed buildings based upon the age of the buildings. The age of the building also affects the vulnerability of building. The topology of surveyed building which were built in between 1927 and 1950 were made of lime mortar and roof were flat roof. Also, some roofs were made of timber which had impact on the condition of building. The *Figure 13* shows the pie chart for comparison between age of building and percentage no. of buildings.

Figure 12 Pie chart of classification based upon Height of building

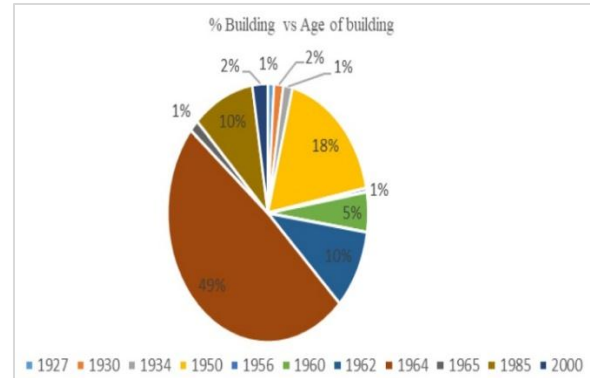
The percentage of surveyed buildings built between 1927 and 2000. The building where not compliant to current Indian standard code and hence are more vulnerable to seismic hazards.

**Figure 13** Classification of building based on Age of building
